# Dale Mine, Warslow: Survey and Interpretation of a Historically Important Lead Mine

# **Dale Mine, Warslow: Survey and Interpretation of a Historically Important Lead Mine**

**John Barnatt**

## ***Summary***

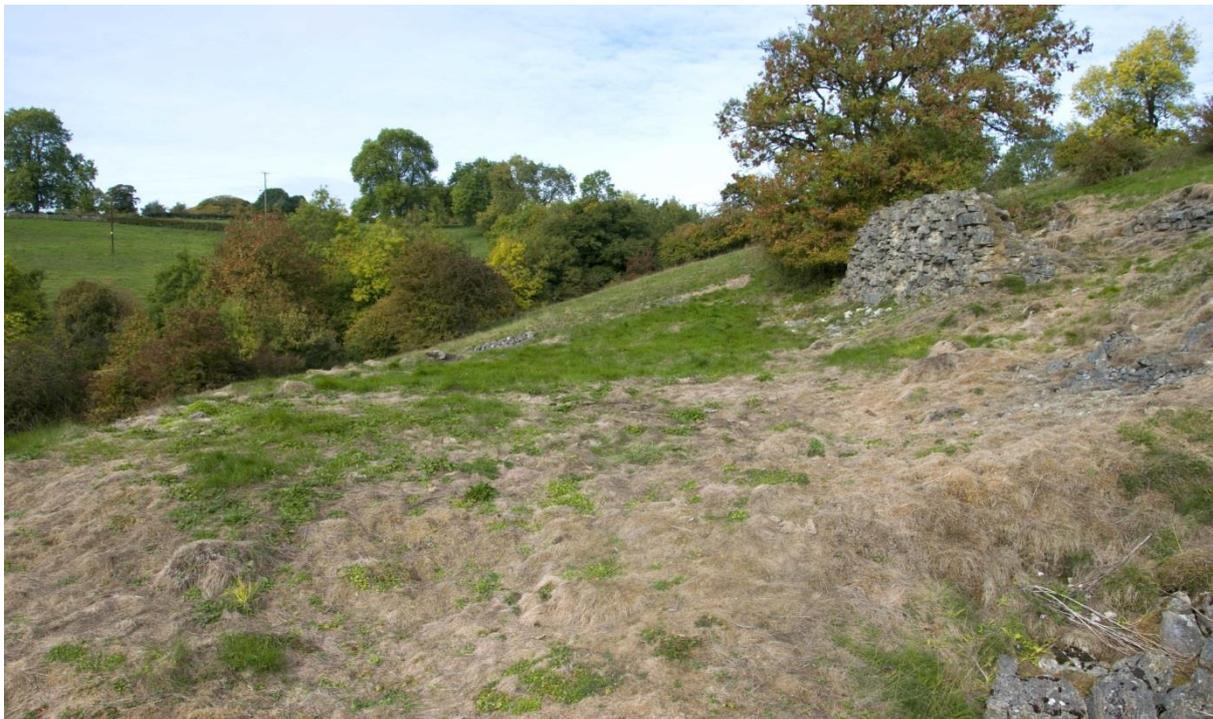
**Plate 11: The lower dressing floor (Feature I), with the bank of 'ore bins' behind (Feature J).**

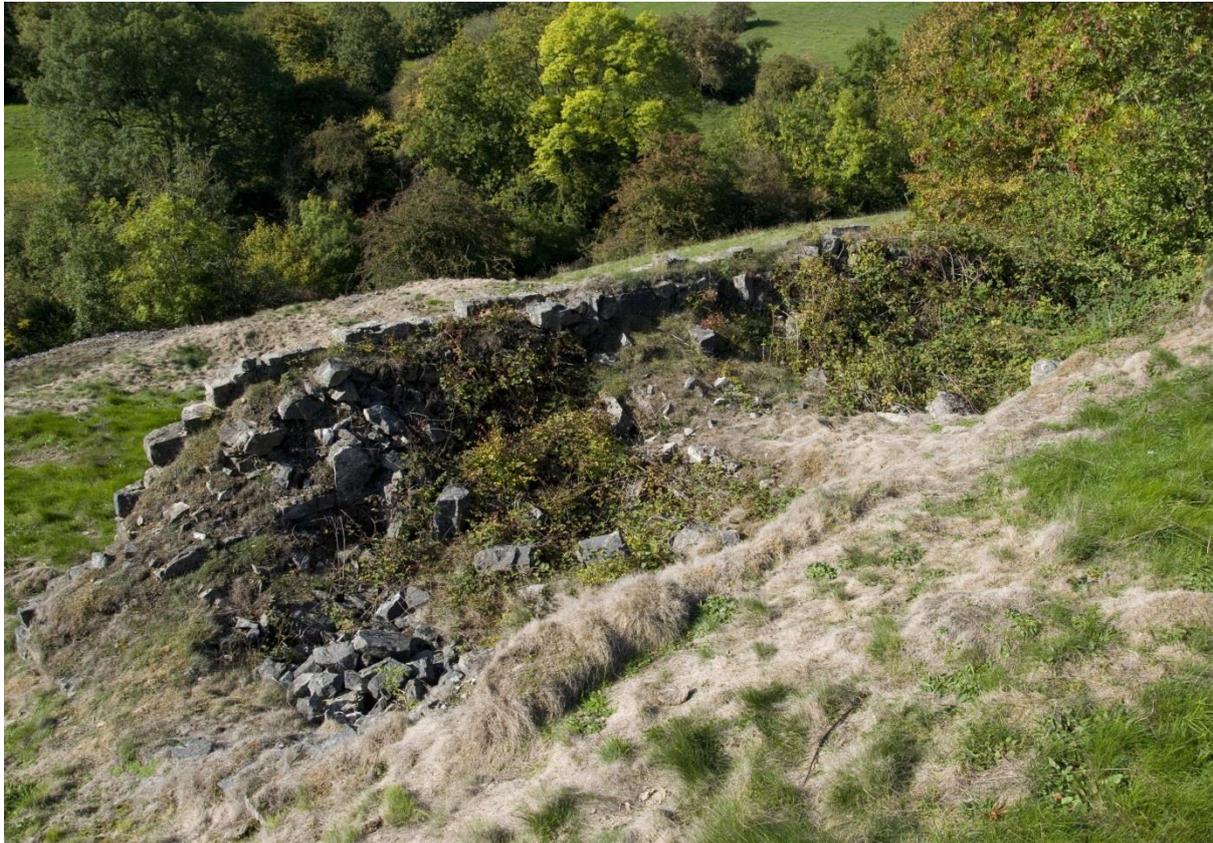
**Plate 12: The south-eastern end of the ruined bank of ‘ore bins’ (Feature J), with rubble-choked tanks visible.**

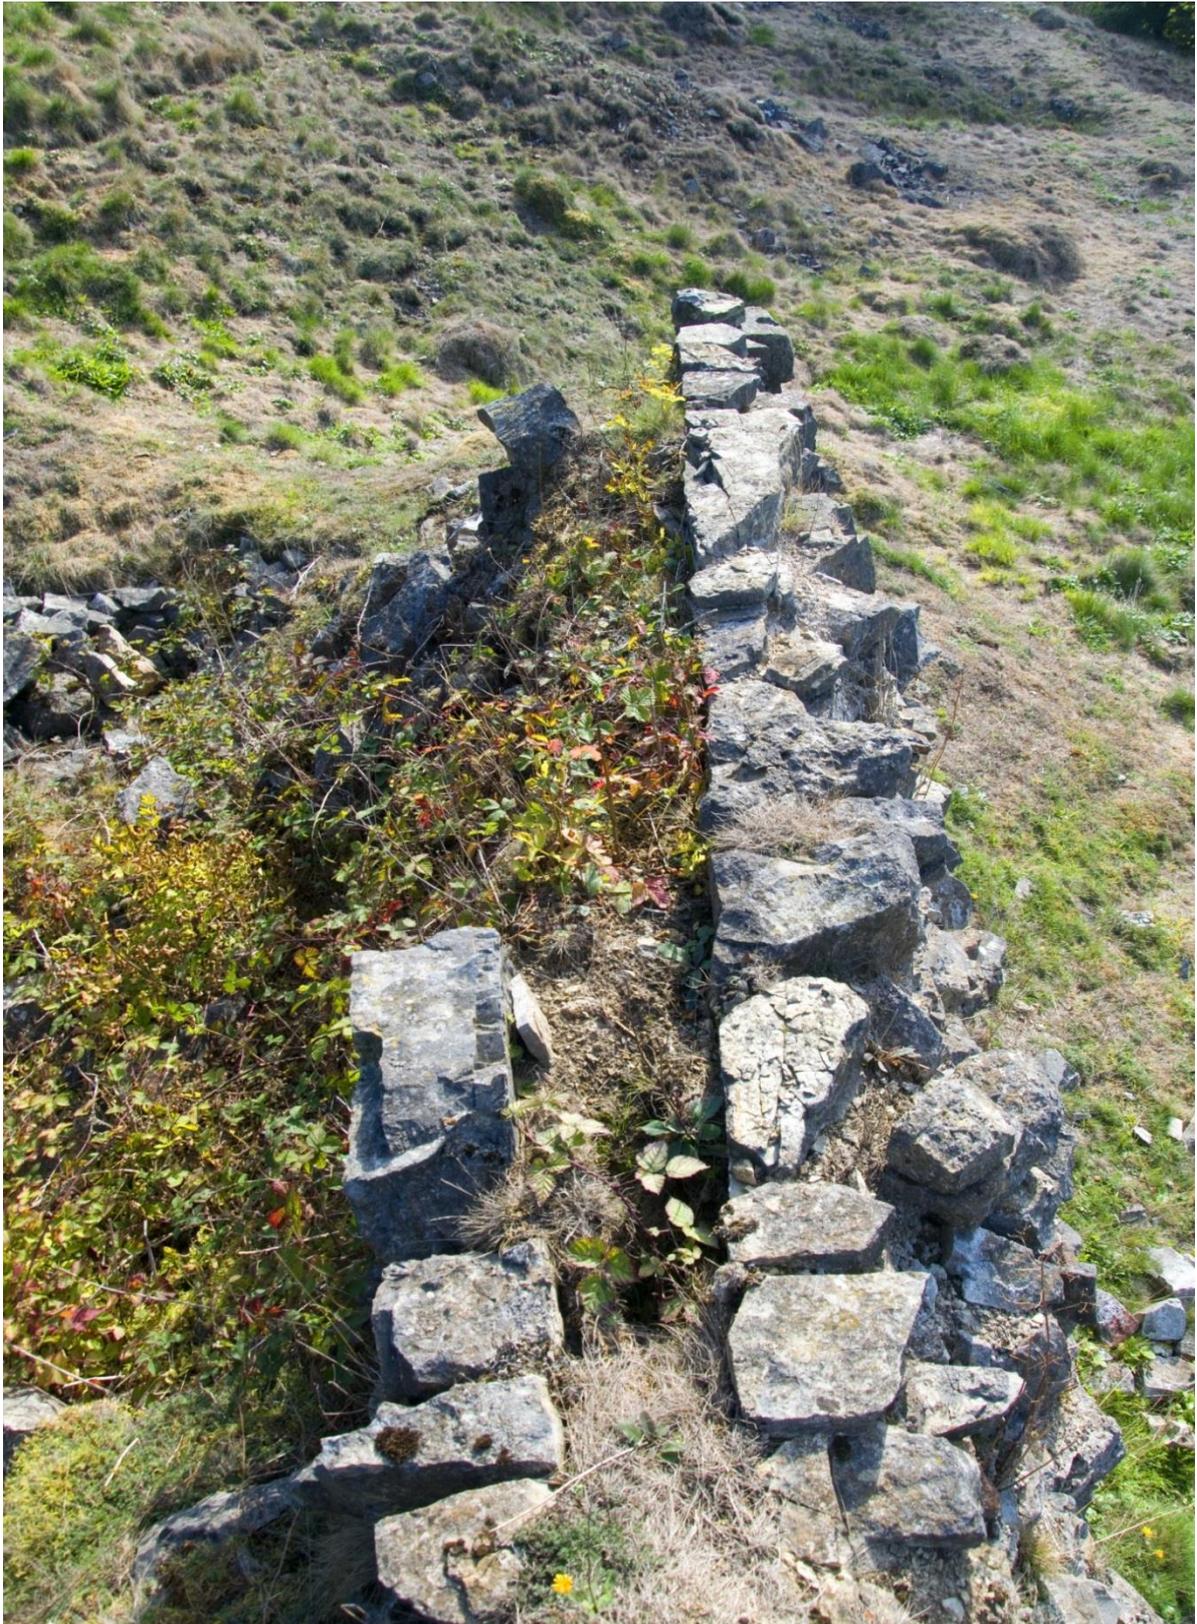
**Plate 14: The top of the retaining wall of the south-eastern ‘ore bins’, showing the two adjacent wall faces with a gap between that matches the position of the long lintel at the timber frames in the openings below; the other faces of the two walls have been robbed in both cases (Feature J).**

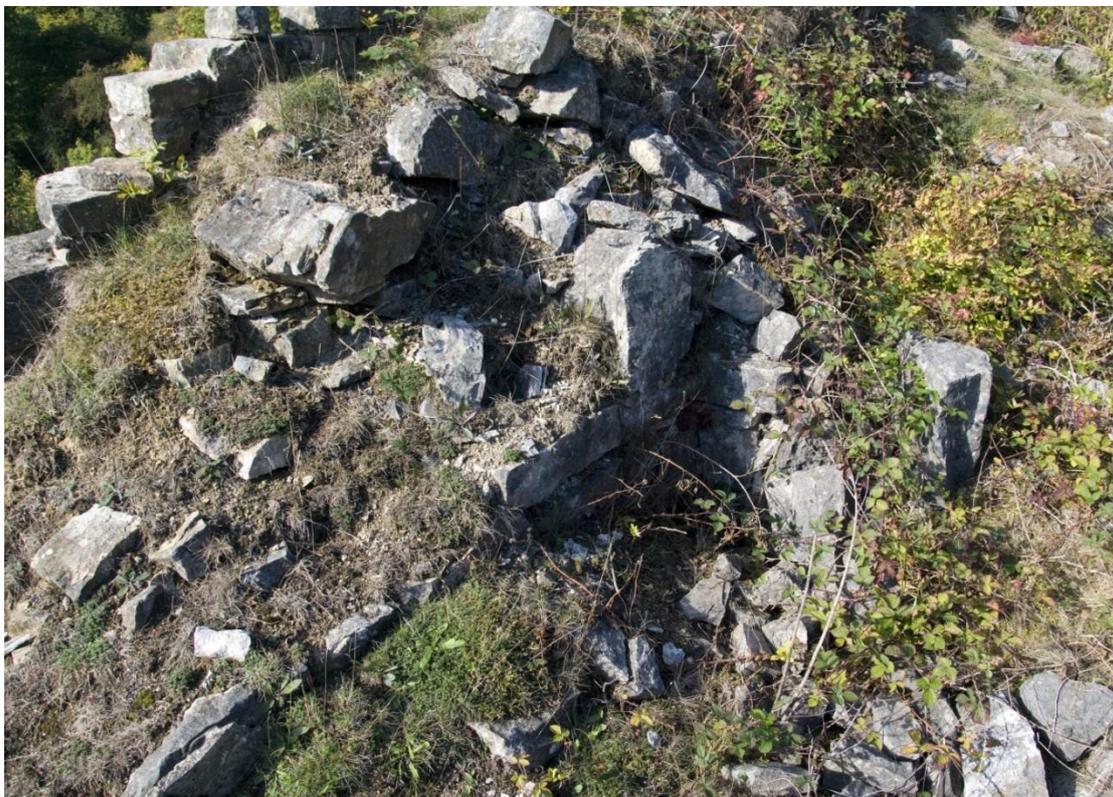
**Plate 17: A corner of one of the ‘ore bin’ tanks, with intact walled vertical sides remaining; elsewhere much has collapsed, been robbed or is buried behind rubble (Feature J).**

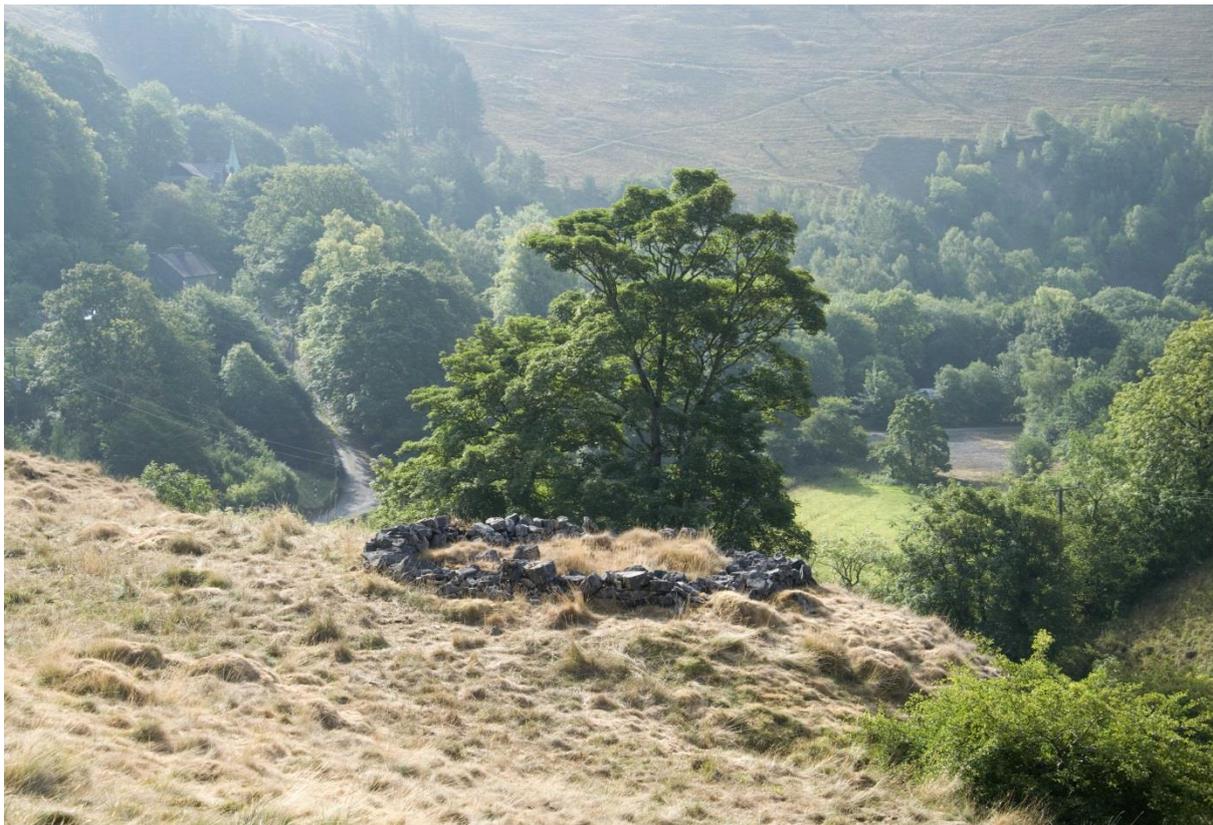
**Plate 19: The robbed wall surrounding the Footway Shaft (Feature L).**

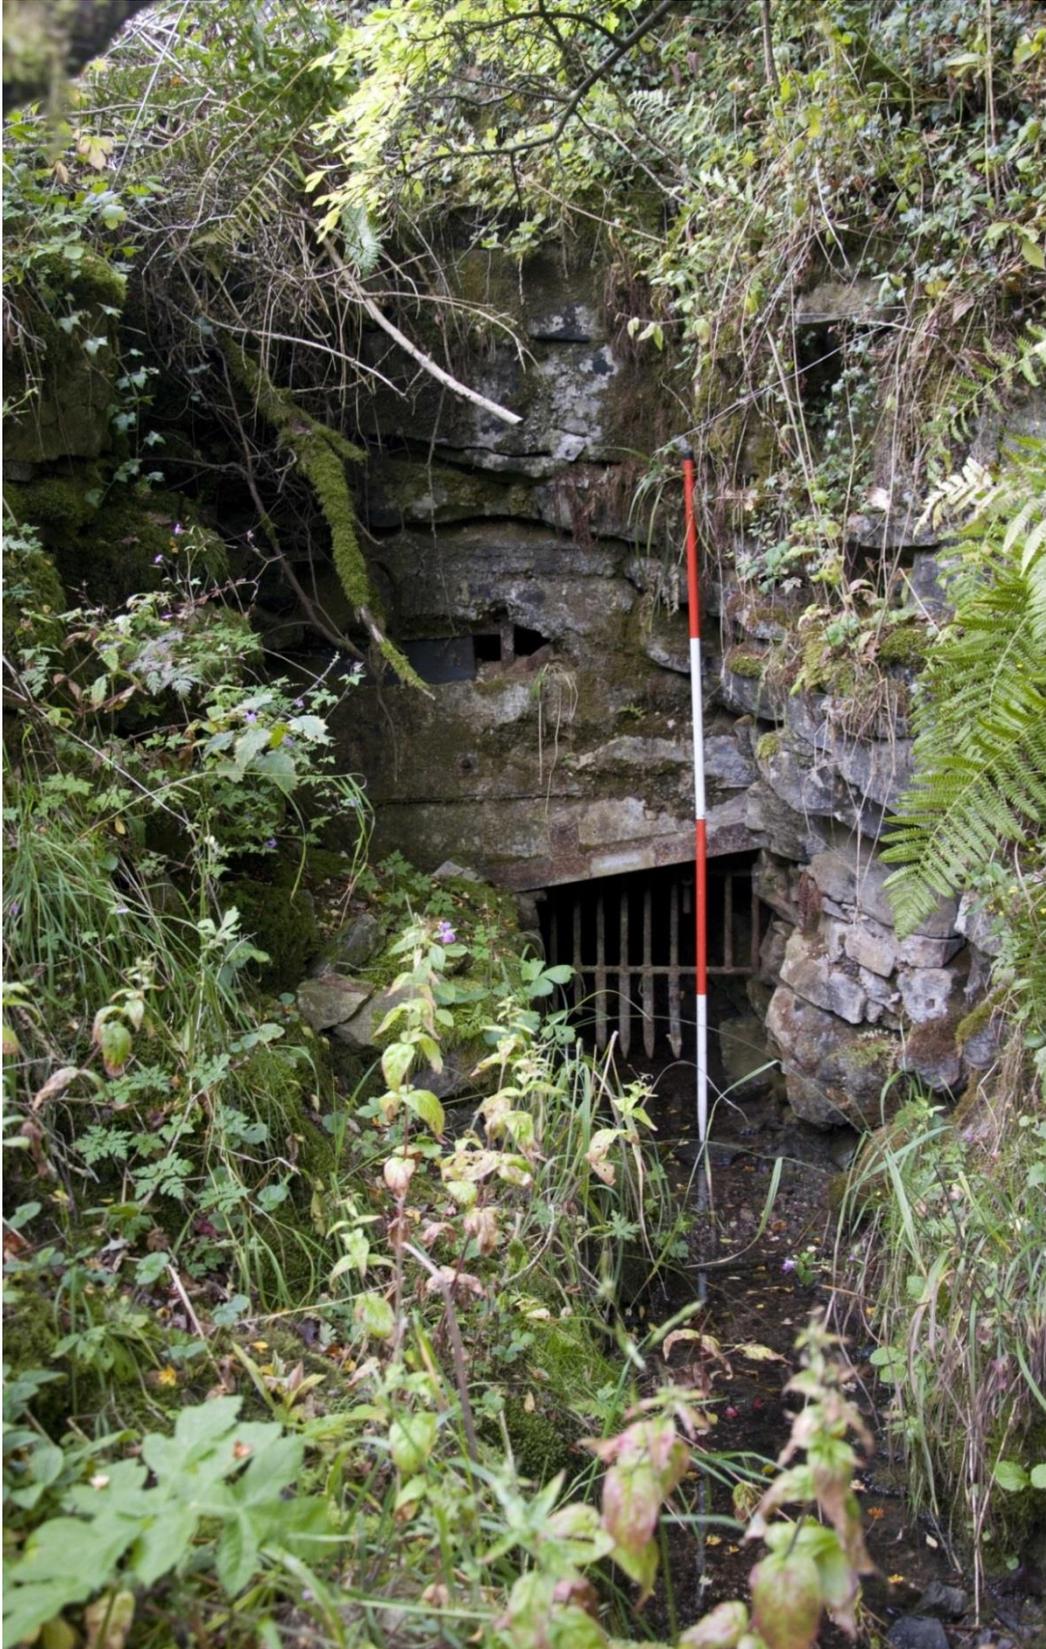
**Plate 25: The partially walled-up entrance to the Dale Mine pumpway (Feature R).**

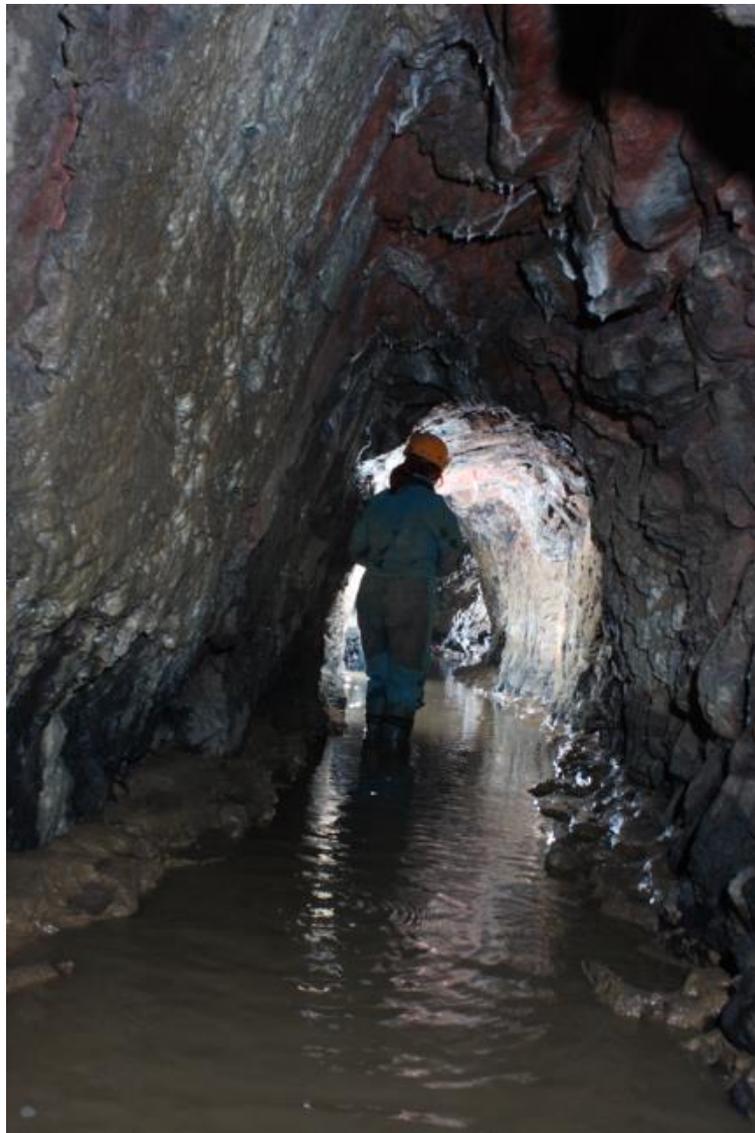
**Plate 30: In the pumpway level, near its start, with left wall at a hading fault (Photograph: Mat and Niki Adlam Stiles).**

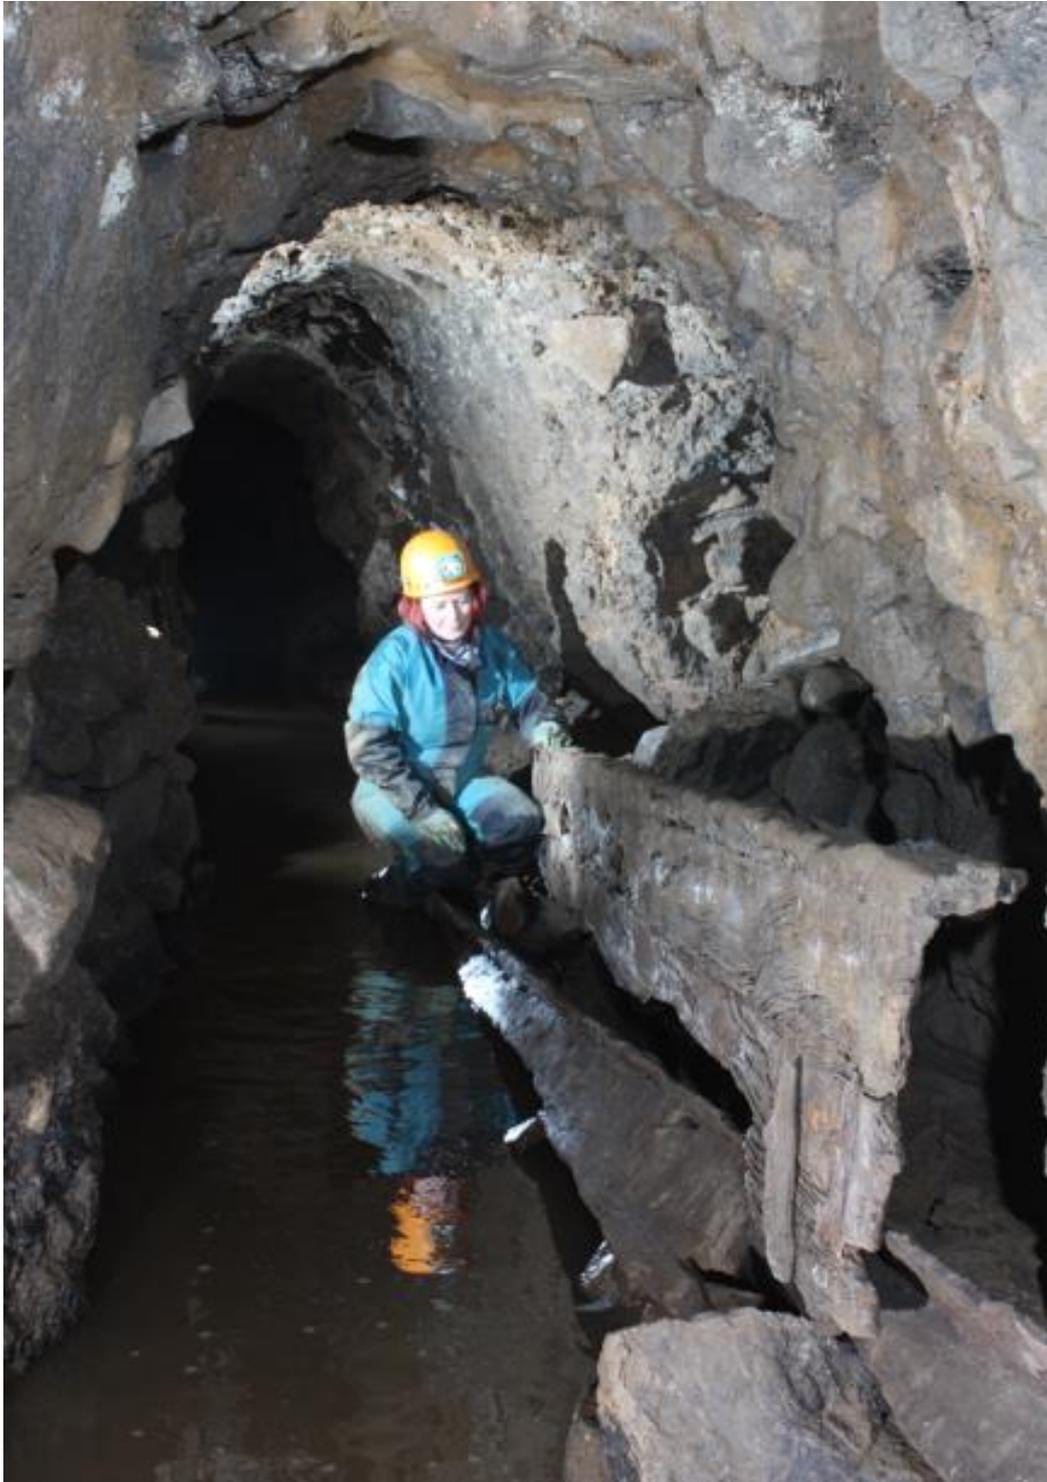
**Plate 32: The surviving northern timber launder in the pumpway level, recently moved from the floor and leant on its side (Photograph: Mat and Niki Adlam Stiles).**

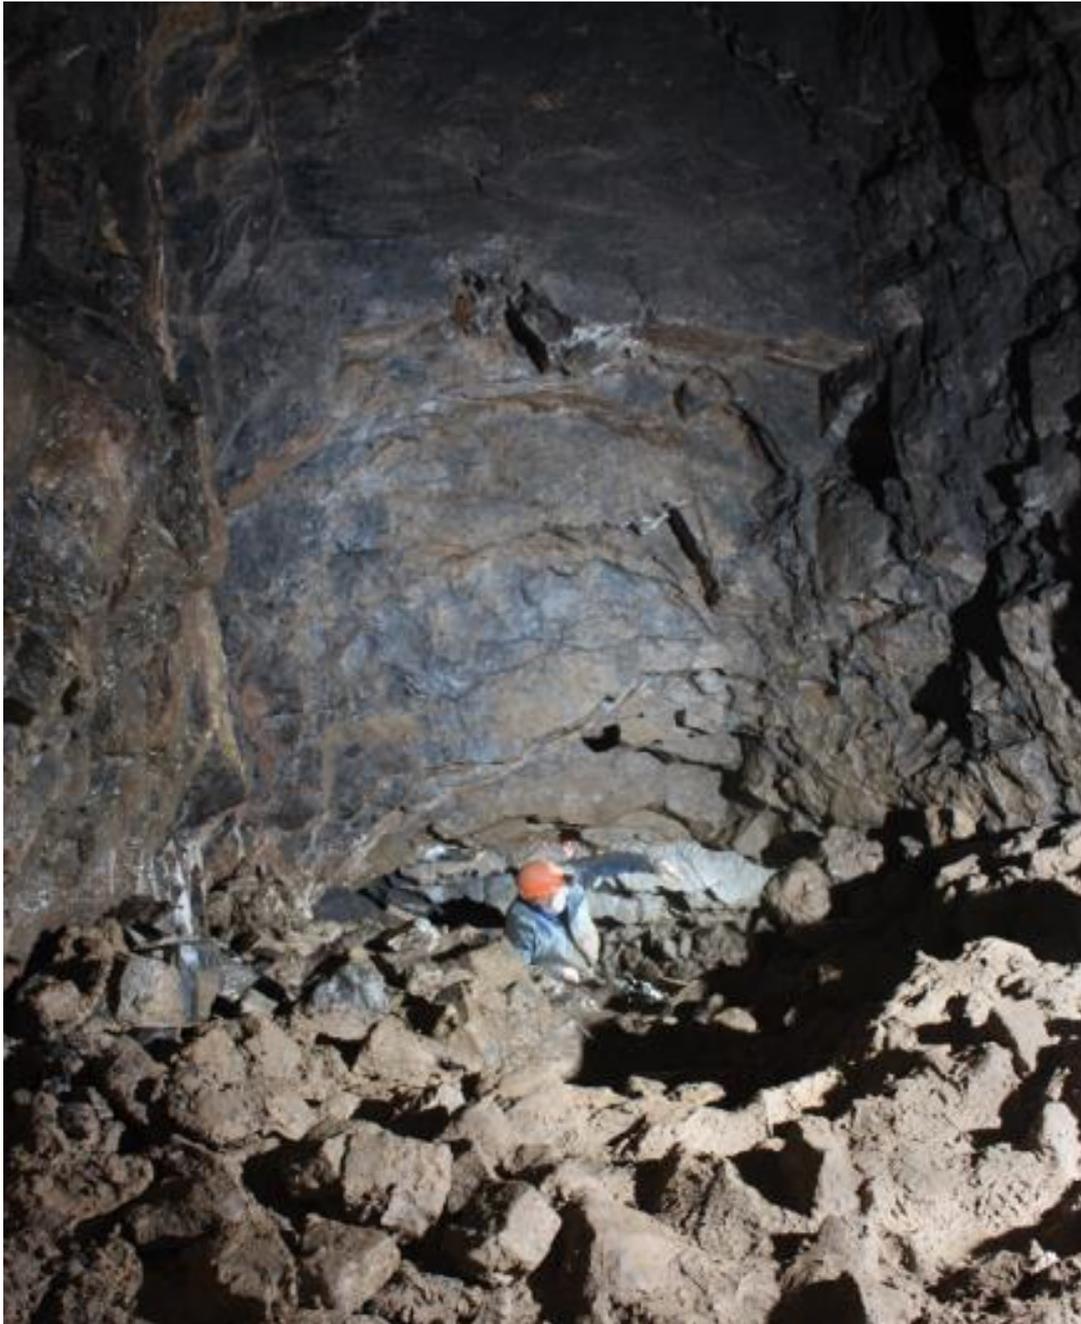
**Plate 35: The south-western end of the abandoned engine chamber, part backfilled with deads, with the pumpway extension out of clear sight below the figure climbing up (Photograph: Mat and Niki Adlam Stiles).**

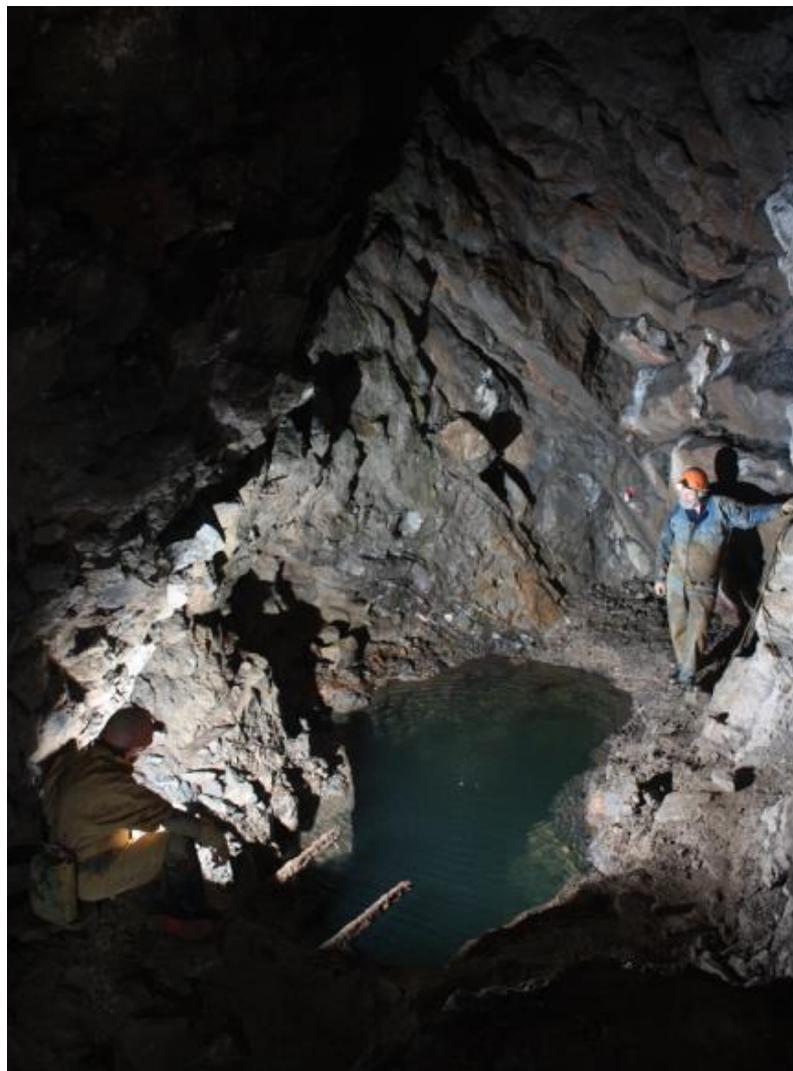
**Plate 45: The flooded downward continuation of the main engine shaft is divided into two compartments; the near half, where the pump rods and pump pipes are likely to have been placed, has reused rails that supported an access platform here. The far half was used for winding ore from depth (Photograph: Mat and Niki Adlam Stiles).**

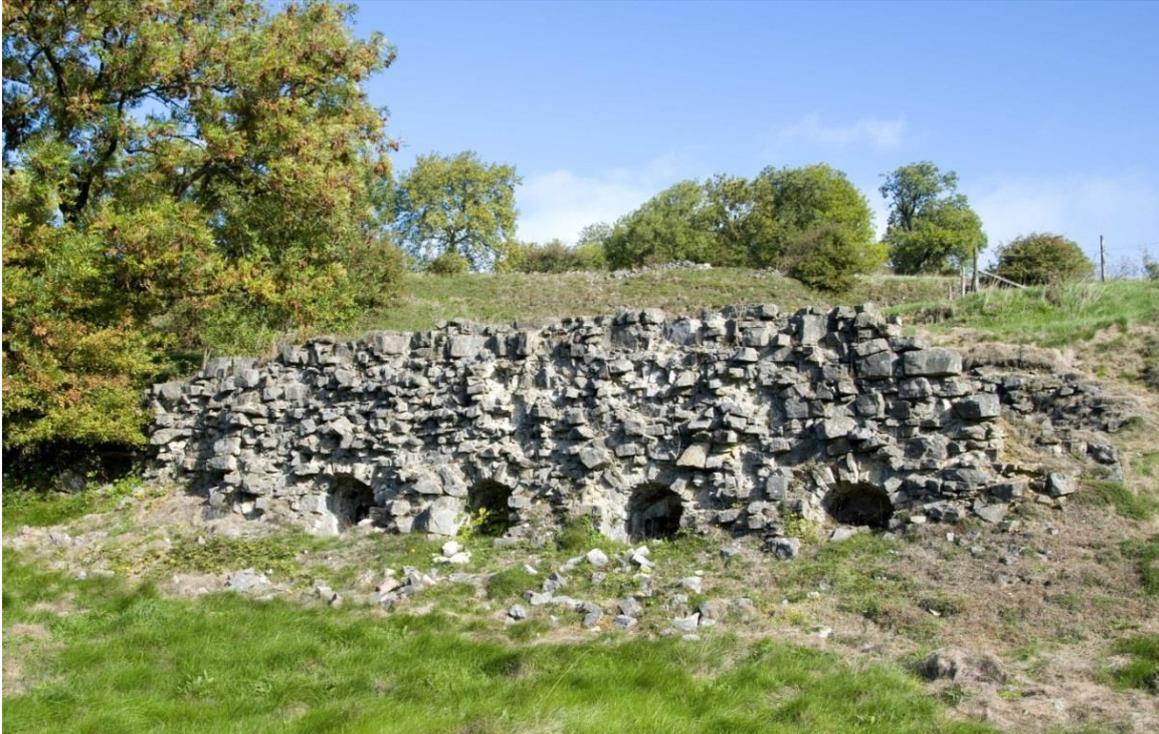
**Plate 46: The south-eastern part of the ‘ore bins’, with robbed retaining wall and four openings that led from the tanks behind; the western half of the ‘ore bins’, where there were two openings, is shrouded by trees but with one of these just visible.**
