SOUTH WEST PEAK LANDSCAPE PARTNERSHIP

Better Outside Case Study: Fernilee Reservoir

Karen Shelley-Jones, Scheme Manager

February 2022

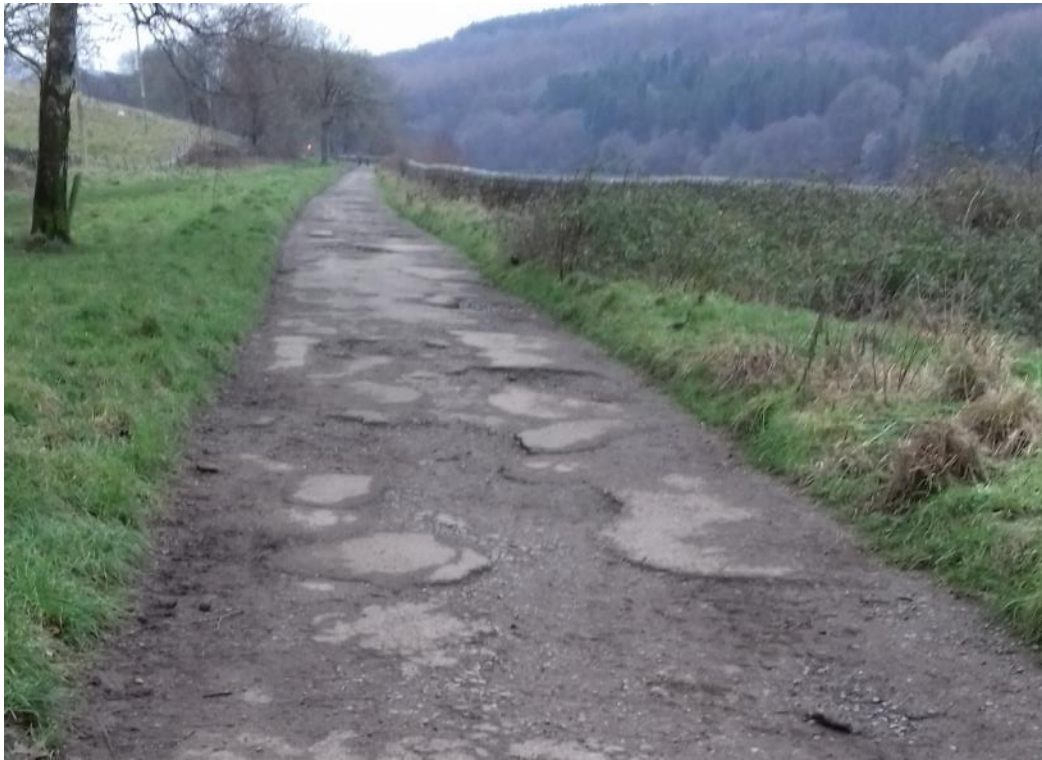
A former railway line (Cromford and High Peak Railway) runs along the east side of Fernilee Reservoir which would be suitable for easy walking, including with buggies. The approach to the route is along a short section of tarmacked road which had a very potholed surface, the track itself was also uneven with pot holes and drainage issues, becoming very muddy in wet weather conditions.

Figure 3. The potholed, uneven approach road

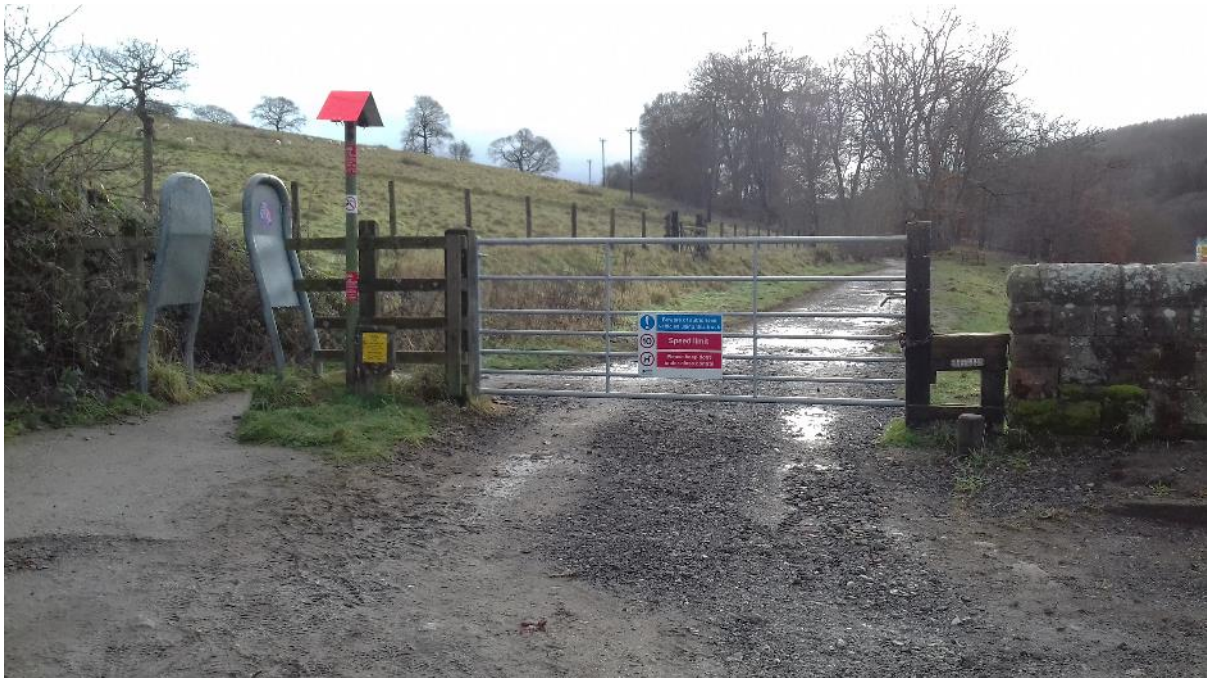
Figure 4. The access gates and barriers at the northern end

An invitation to tender was produced and a contract let to resurface the main track and replace the motorbike inhibitor barriers at either end with large kissing gates suitable for use by all sizes of wheelchair and mobility scooter (the Woodstock kissing gate made by Centrewire).

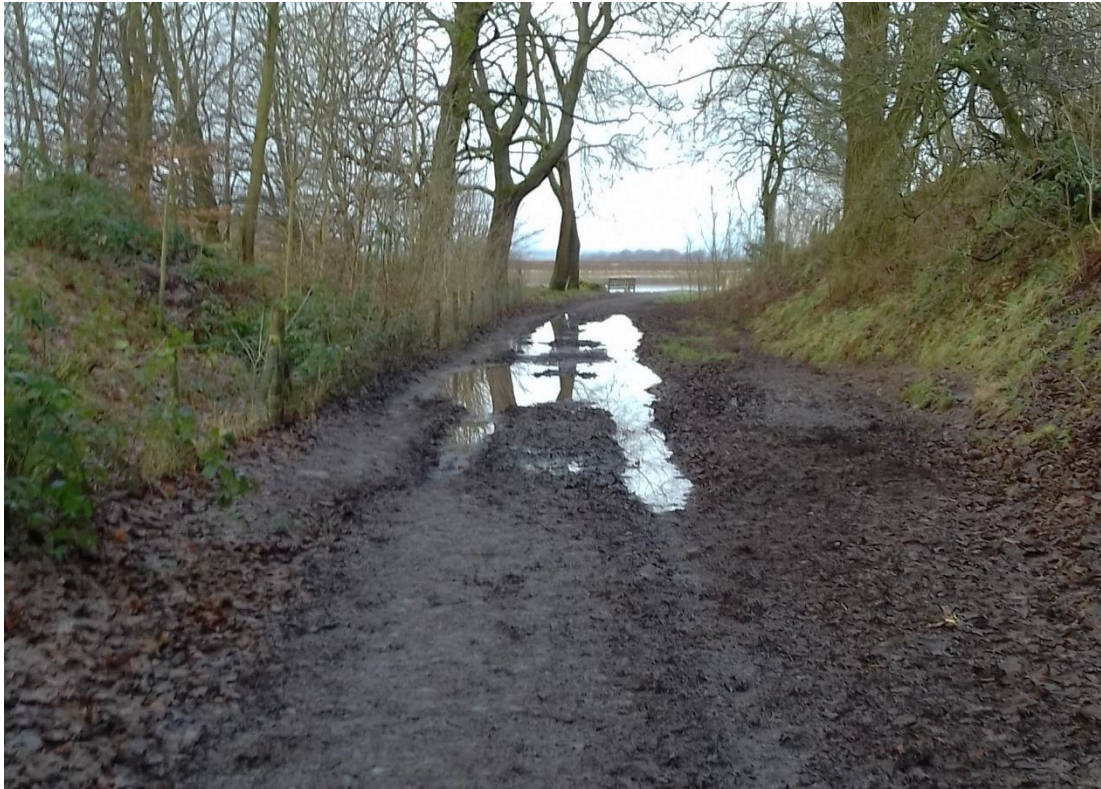
Figure 5. Poorly drained muddy sections, particularly beneath trees

In the wettest muddiest area (shown in figure 5) a 'French drain' was installed to aid drainage.

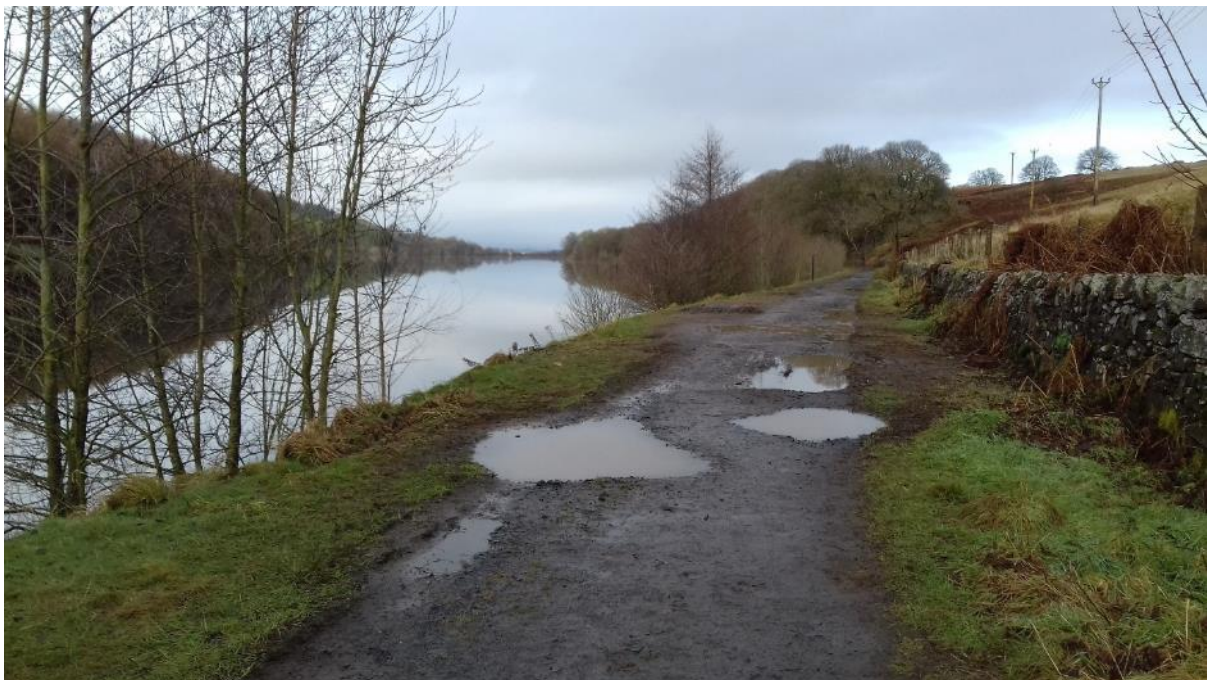
Figure 6. Potholes all along the route

The material used was self-binding gravel of naturally excavated materials appropriate to the site location, graded 12mm to dust (approx. 2 tonnes : 1cu m) and laid using a suitable machine to a finished thickness of 50mm over a sub-base.

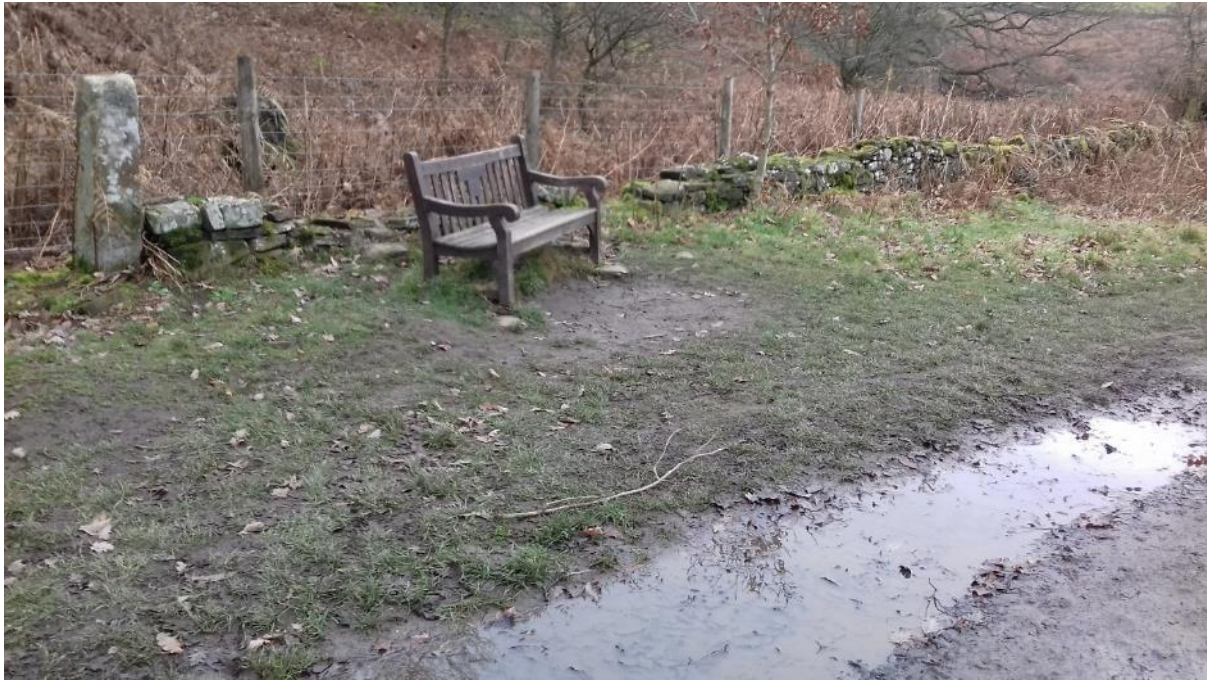
Figure 7. Degraded benches

Existing benches were refurbished with our team of Countryside Worker apprentices and volunteers from Tarmac; and three new benches installed in suitable locations.

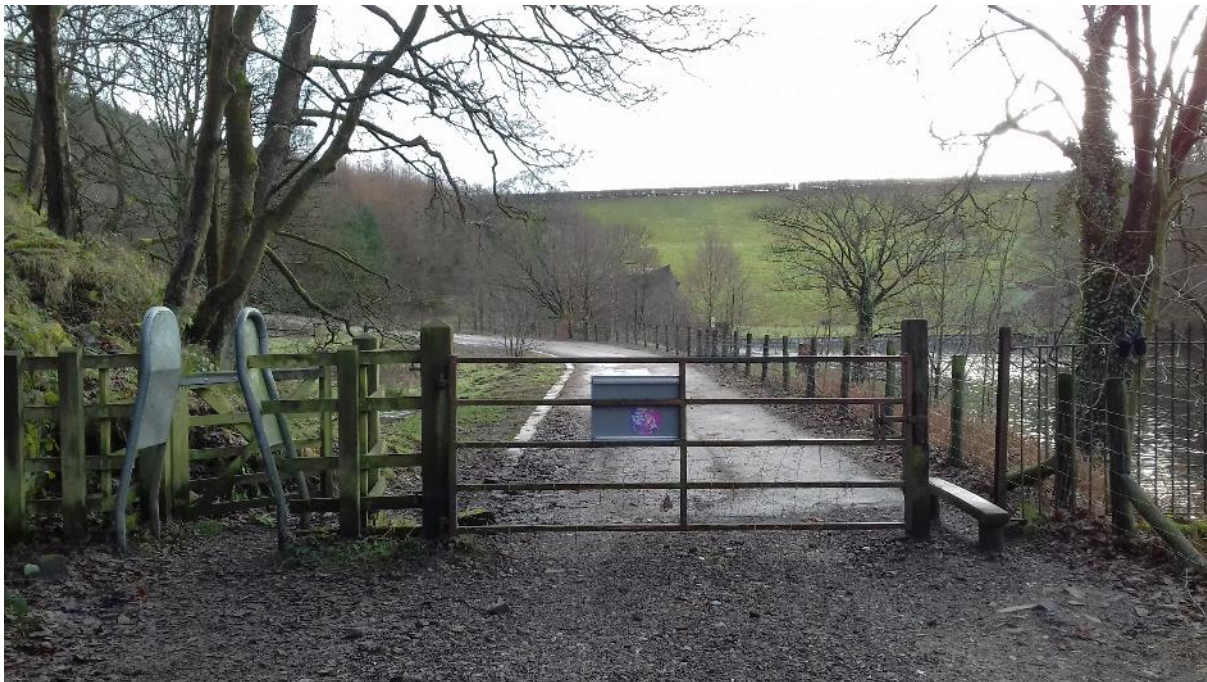
Figure 8. Access gates and barriers at the southern end, note motorbike inhibitor and wicket gate

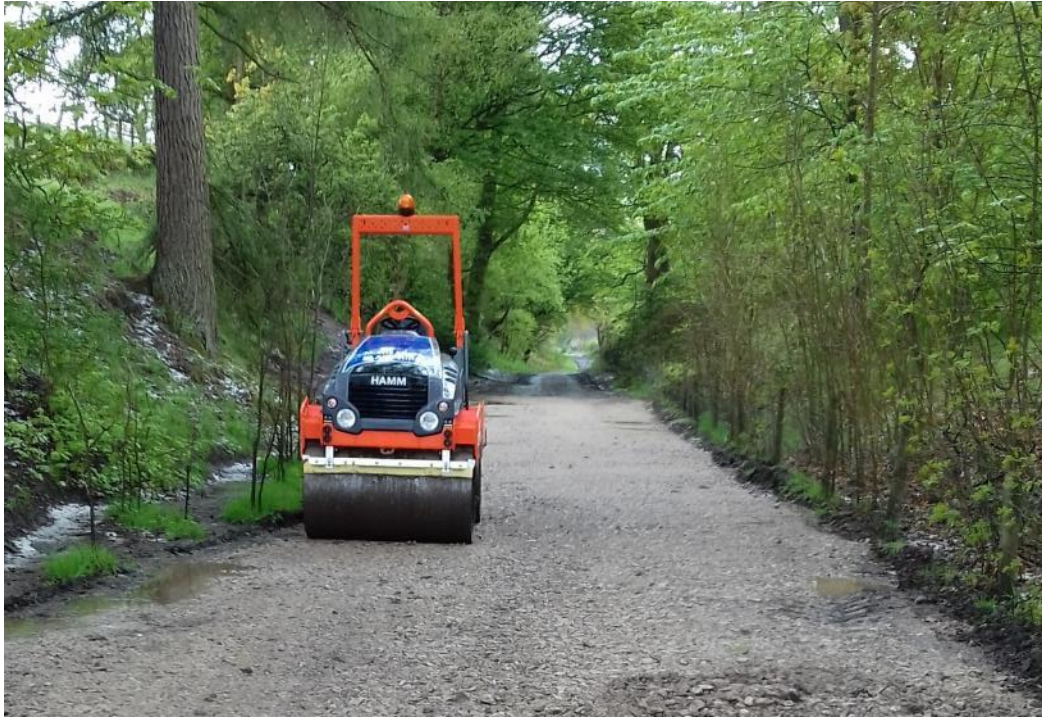
There were some challenges experienced in achieving the required smooth compacted surface, this was due to the limitations of the material itself, ensuring consistency of load from the quarry to achieve the desired ratio of gravel to dust and the final machine grading.

Figure 9. Re-surfacing in progress in May 2019

Remediation works were required to remove loose gravel and re-compact the top dressing.

Additional site constraints included a high pressure gas main, water main and electricity cables. Detailed working methodology had to be agreed with Cadent in relation to the position and vulnerability of the gas main, which restricted the type of roller that could be used to compact the top dressing (no vibrations), and the depth and position of digging required to install gates and benches.

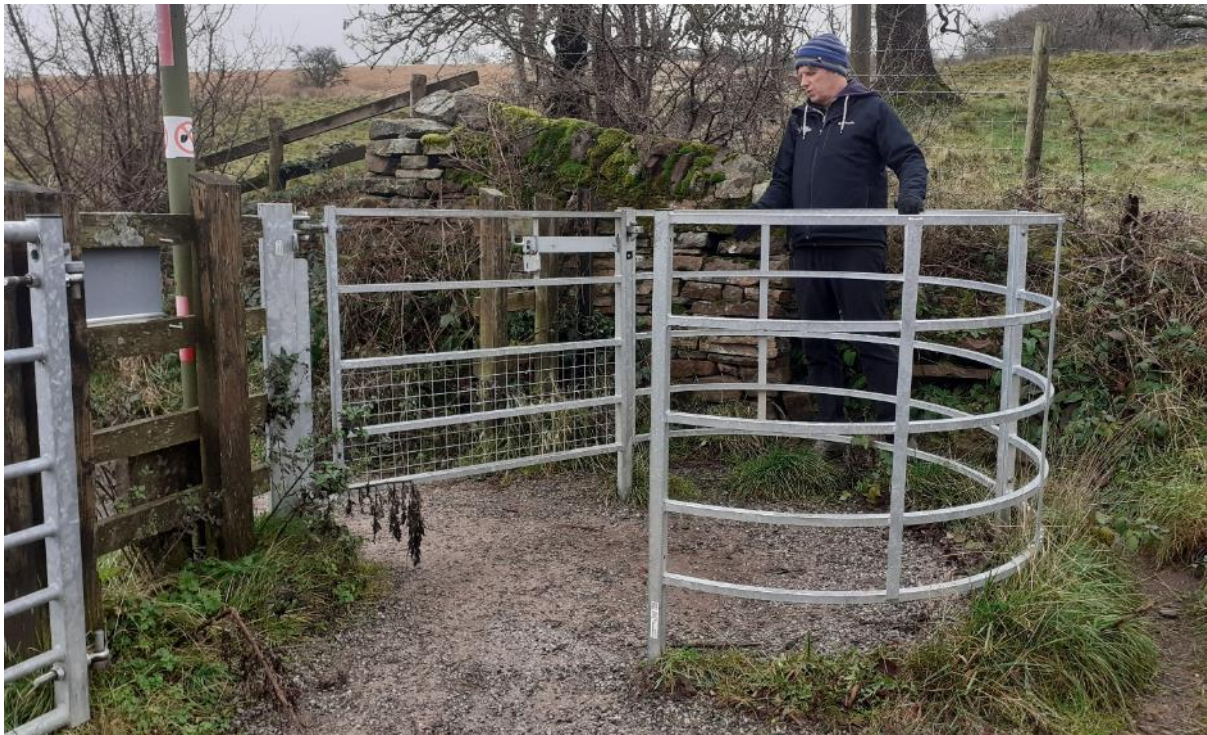
The newly installed access gates enable access by a range of users. Their design enables them to function as a regular kissing gate for most pedestrian and small to medium sized wheelchairs and power chairs; with the addition of a slider that is operated with a radar key (available for disabled users from their local council) which opens the swing gate wider enabling free access.

Figure 10. The replacement mobility kissing gates

However, other users of the route did not like the new gates as they felt that they impeded access for bicycles and bicycles with trailers. Post-installation it became apparent that the gates were not functioning correctly, possibly as they had been adjusted or possibly due to their installation being compromised by the location of a high pressure gas main in this location which meant positioning and depth of holes for installation were very restricted, and could not be altered from position and depth of the original structure.

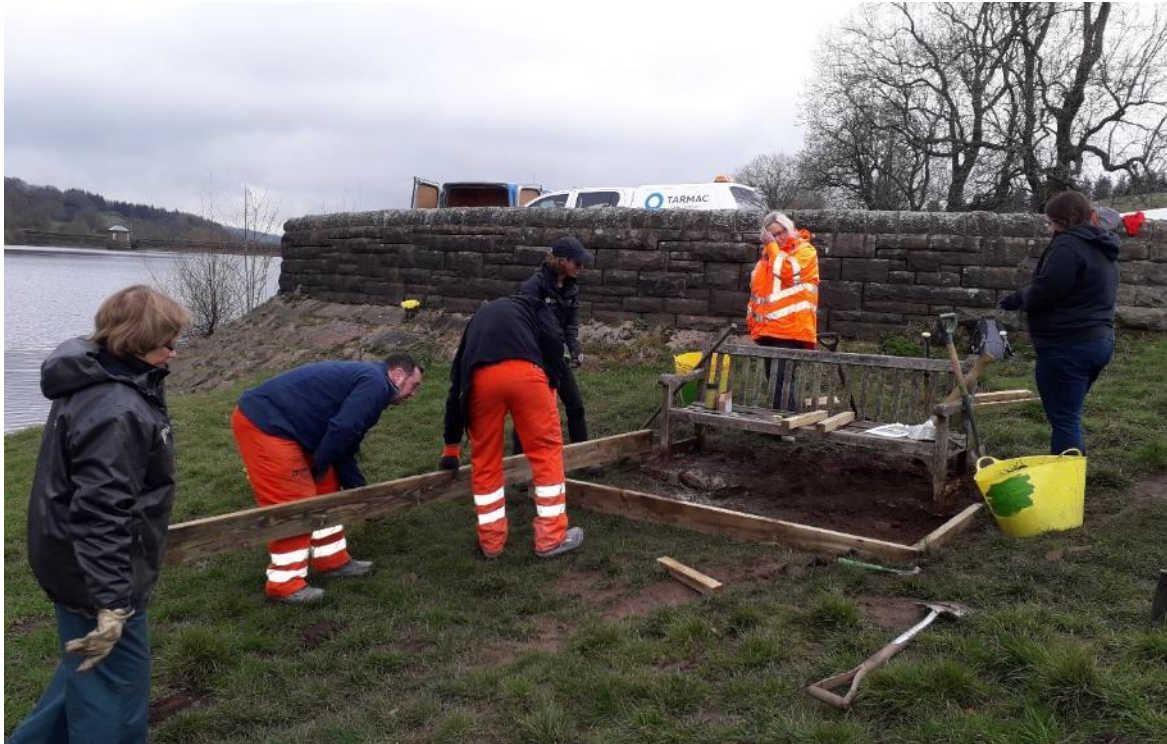
Figure 11. Volunteers from Tarmac helping to re-furbish benches

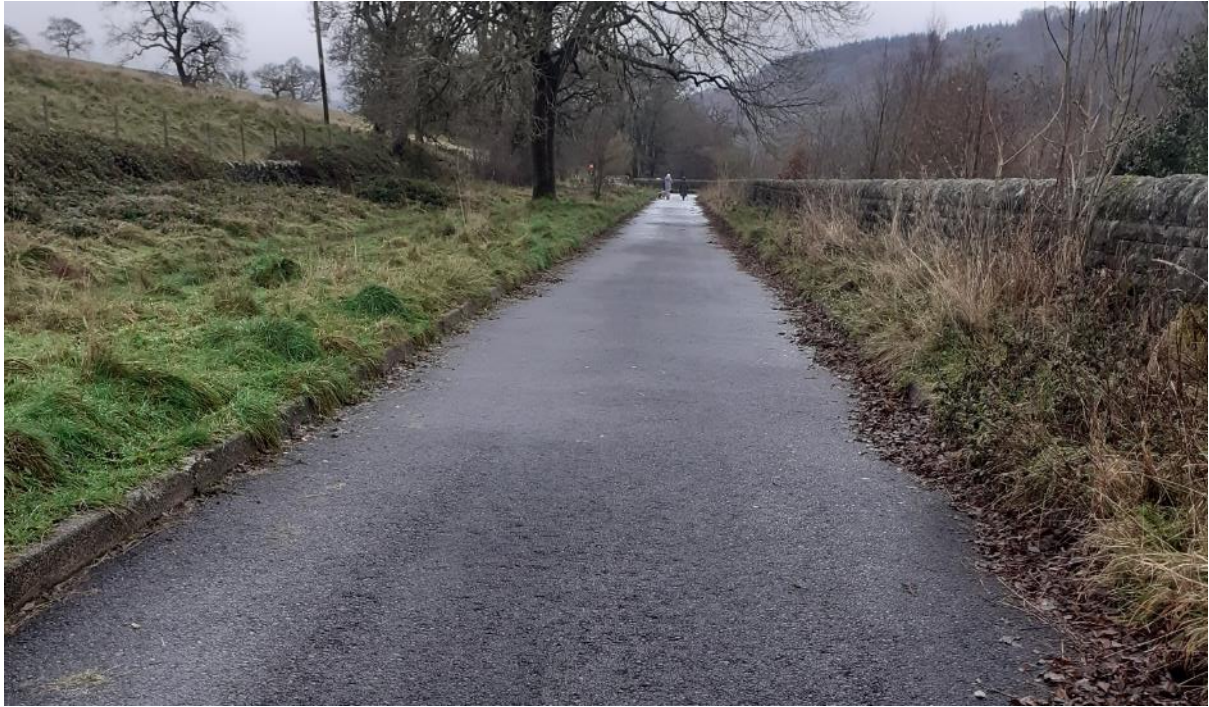
Figure 10. The newly tarmacked approach road

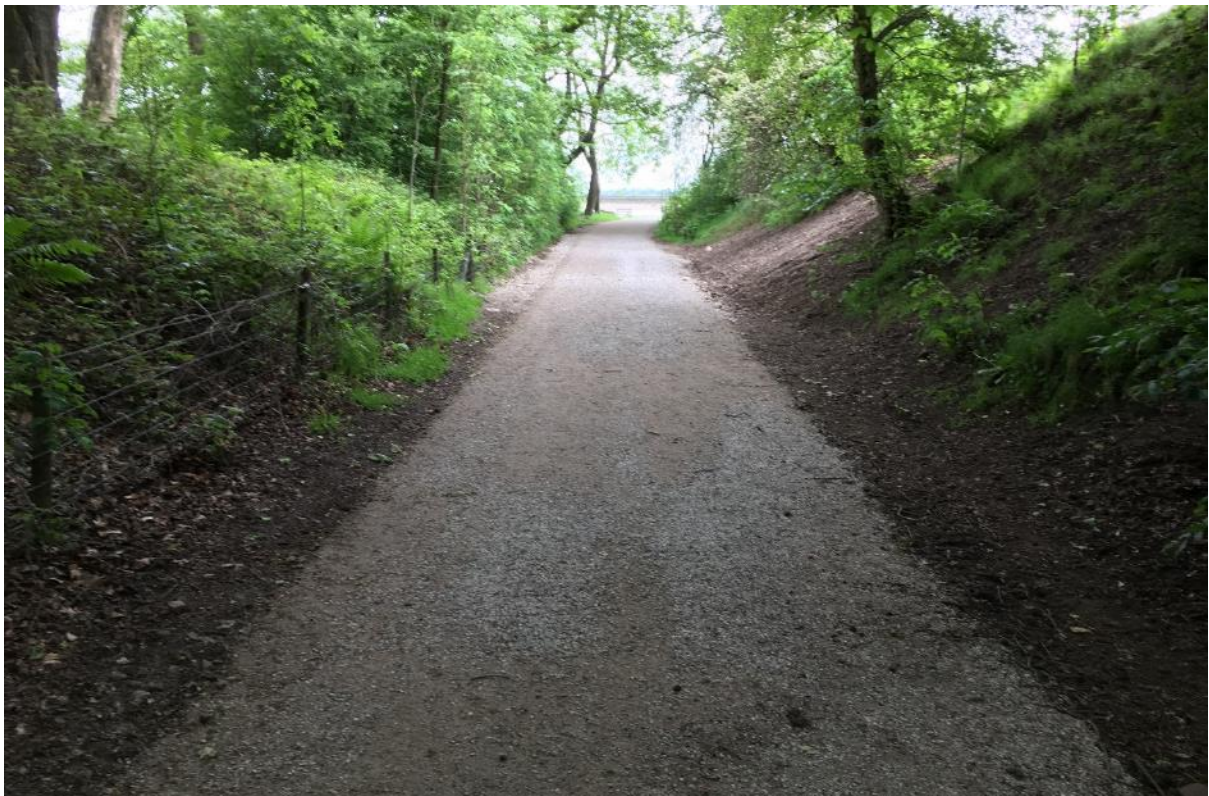
Figure 11. The previously muddy section immediately after works in June 2019

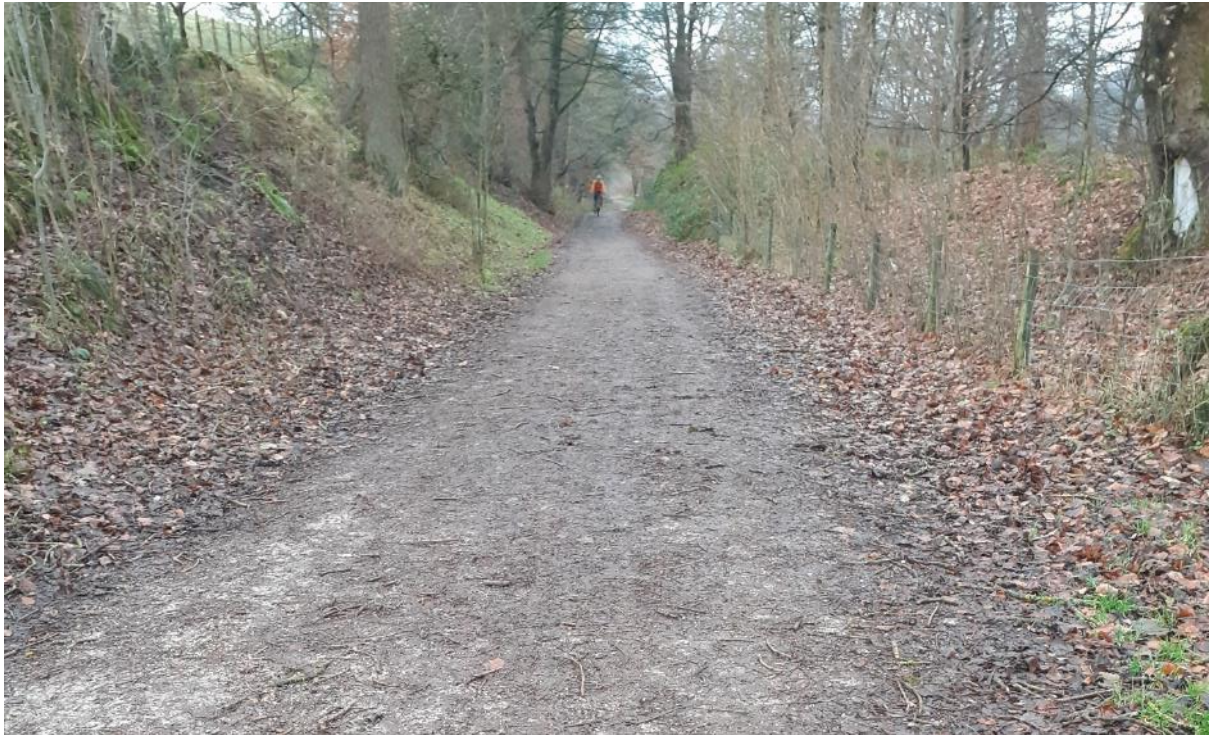
Figure 12. *The same section (photograph taken from opposite direction) in December 2021*

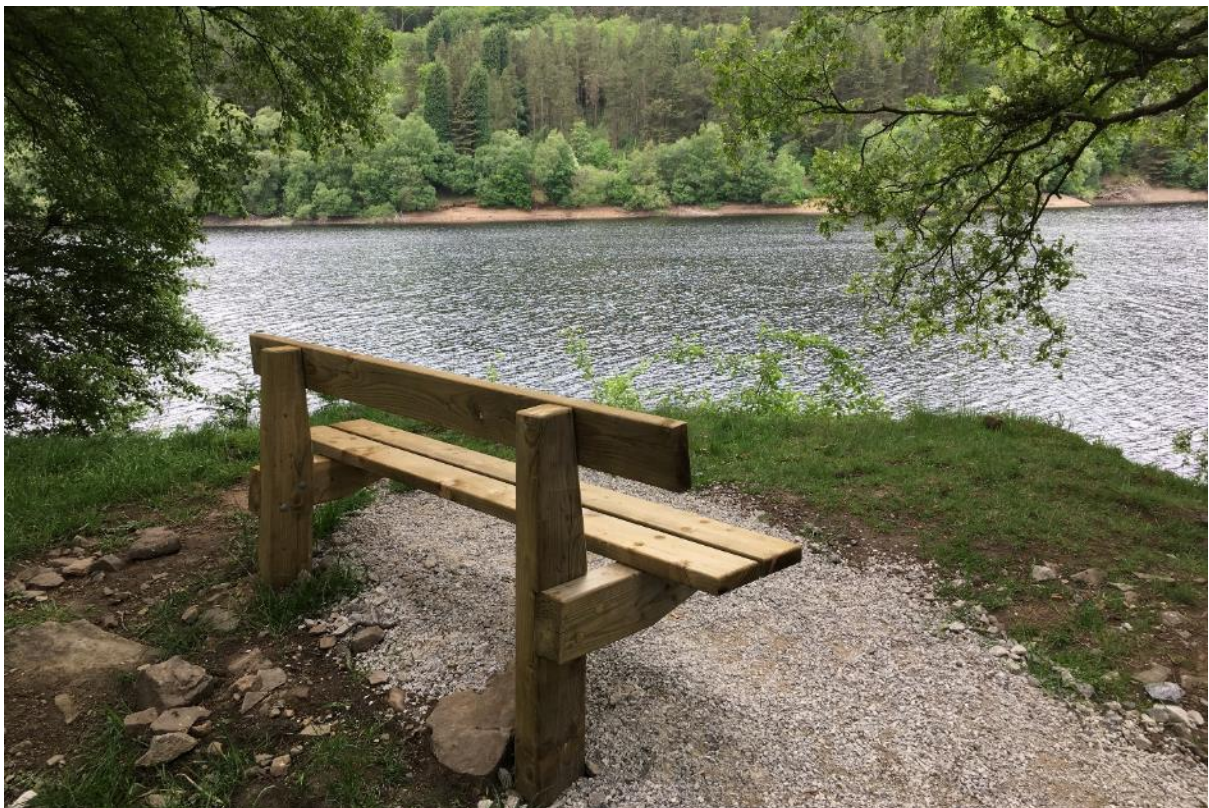
Figure 13. *One of the new benches enjoying the view over the reservoir*

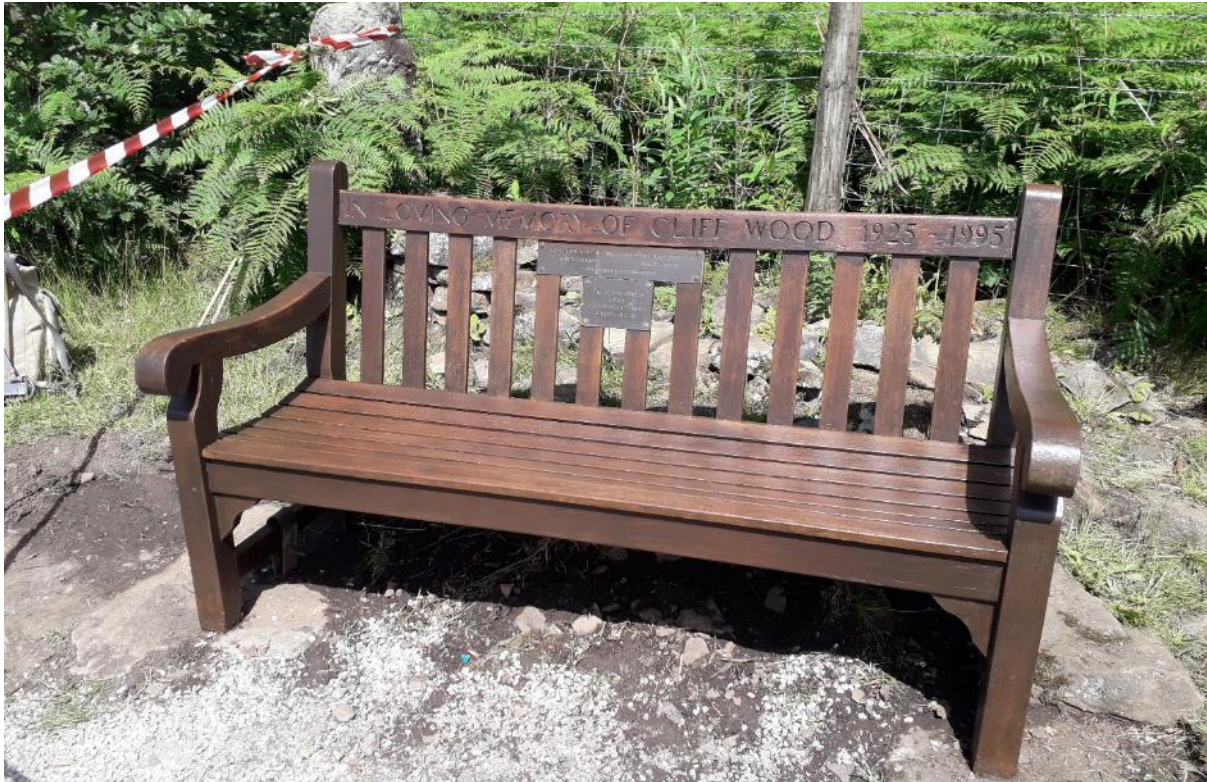
Figure 14. An existing memorial bench, revitalised
