Location: Firth Bottom Fen, Tittesworth
Water course: Meerbrook
Sub-catchment: Churnet, Upper Dove

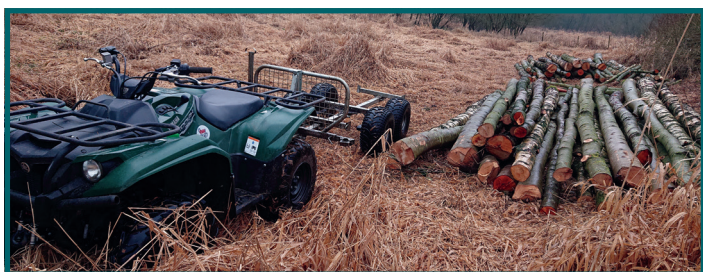
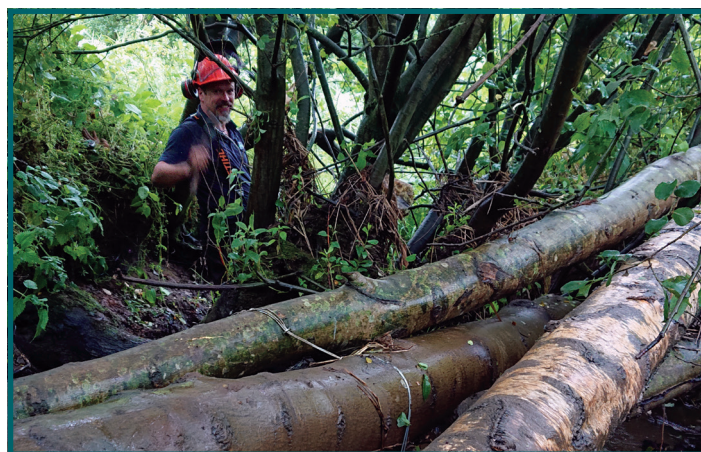
The stream running through this site was highly incised and very disconnected from the flood plain. The silt regime was poor and had disproportionate quantities of fine sediment loading. The flow rates were high after heavy rain but the degree of bank incision prevented the turbid waters from readily connecting with the fluvial silt deposits on the flood plain. By creating leaky woody barriers, the stream now has more resistance to high flows as water backs up behind the features and spills out more readily onto the banks throughout the wetland habitat. As this stream feeds a reservoir this work also facilitates the reduction in silt arriving in the reservoir reducing treatment costs.

Leaky woody dams have multiple benefits. Firstly, and crucially, these dams reduce flow rates meaning peak flow conveyance is much slower. Secondly, they have a localised positive impact on the amount of silt suspended in the water column as they push flood water out onto the flood plain where silts can be deposited readily. Woody dams also provide positive benefits for aquatic wildlife too as they create habitat for many invertebrates, fish, lower plants and fungi. Woody material in watercourses serves as a resource for ‘shedders’ and ‘decomposers’ amongst the invertebrate populations, which they can convert into a form that other wildlife can utilise further up the food chain. Woody dams can also provide a foraging perch for riparian birds such as dippers and wagtails. The benefits span much further than just Natural Flood Management and slowing the flow.

- 15 LWD leaky dams
- 400 m of watercourse providing storm water attenuation

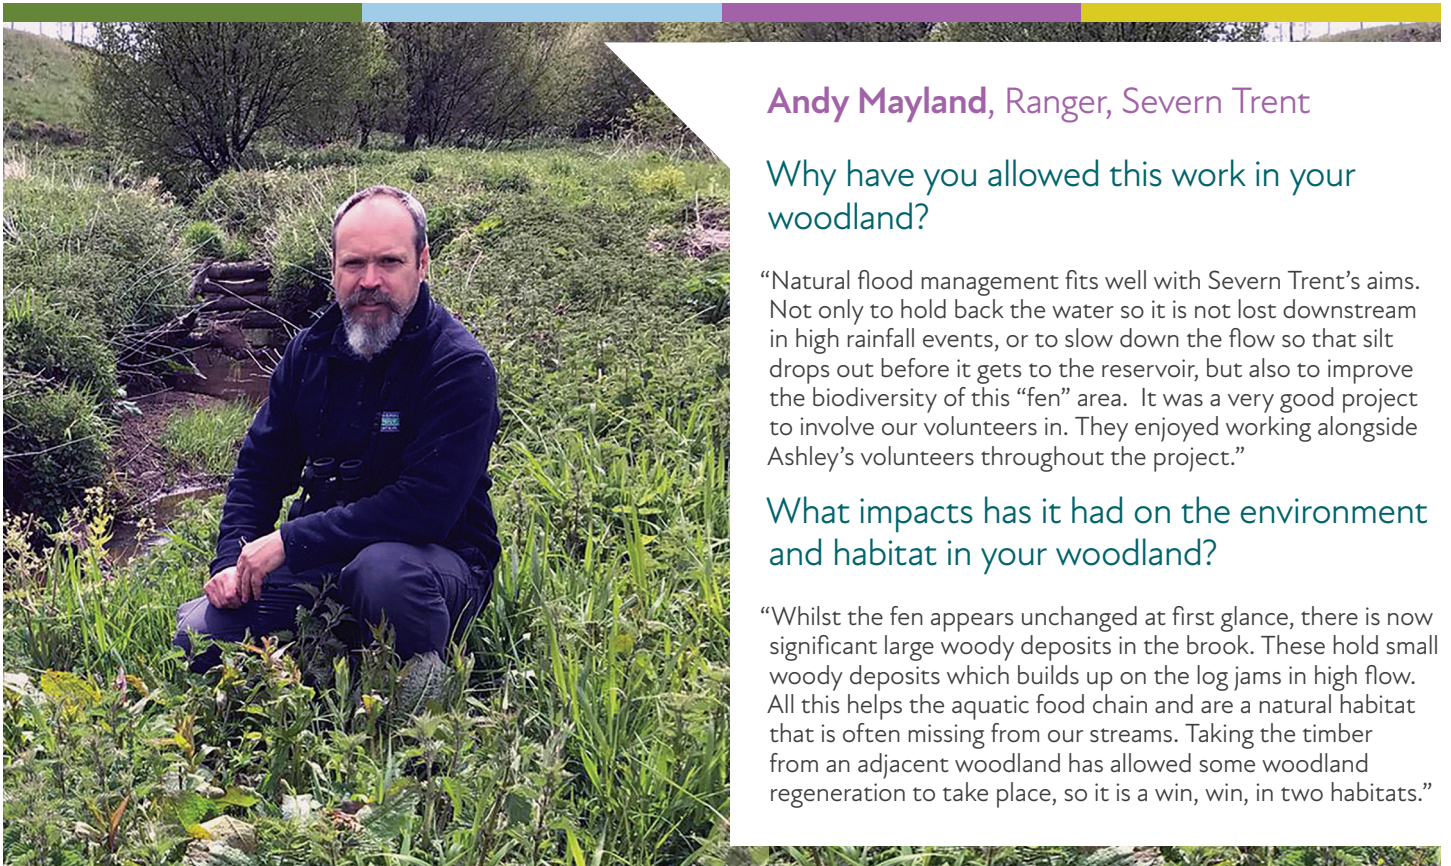
The installation of the dams was linked intrinsically to woodland management in the immediate vicinity. The wetland habitat is adjacent to a plantation woodland which required thinning work. This provided the timber for creating the leaky dams. The trees were felled by trained arborists who prepared the timber into 4m lengths so that it would span the channel (with a third of the timber extending the width of the channel into the banks each side). Extraction of the timber from the woodland was achieved using volunteers. Once the timber was out of the woodland, a quad bike, on floatation tyres, was used to transport the timber along the stream to the locations of each leaky dam. The installation of each timber dam was done using volunteers and no machinery tracked across the habitat to build the dams. Instead, each structure was done by hand. This was achieved by digging a slot on each side of the stream and lowering the timbers into the slot to create a leaky barrier. This enabled each structure to be 'keyed' into the bank. The base of each dam was situated above base flow so that during low flow conditions water could pass unimpeded beneath the structures. Non-tanalised fencing stakes were then knocked into the ground in each bank adjacent to the timber so that the dams cannot move downstream under high water pressure. Each timber length was secured to the stakes using plain wire and fencing staples. The slots were then backfilled with soil on each side to ensure the timbers were anchored into the river banks. Each dam was located strategically in the channel to maximise engagement of peak flows with the flood plain. They were keyed into the channel in locations that would encourage the most water out of the channel and therefore provide the most storm-water attenuation during heavy rain-fall events.
